TEST REPORT

No. : XMIN1905003438ML

Sample Name : SUNRACK SOLAR L FEET
Product Specification : SR-L
Material and Mark : AL6005-T5

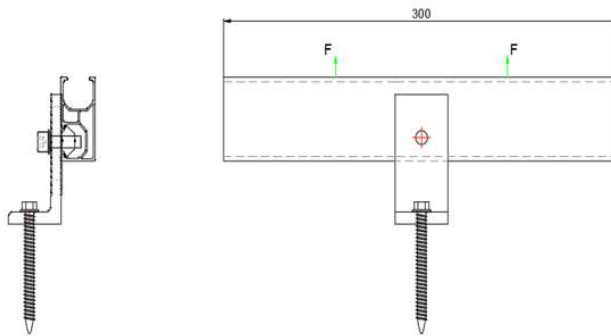
The test sketch:

Test method: according to the client's requirements, fix the sample on the test machine. Apply the pull force as a rate of 5mm/min till destruction. Determine the maximum force.

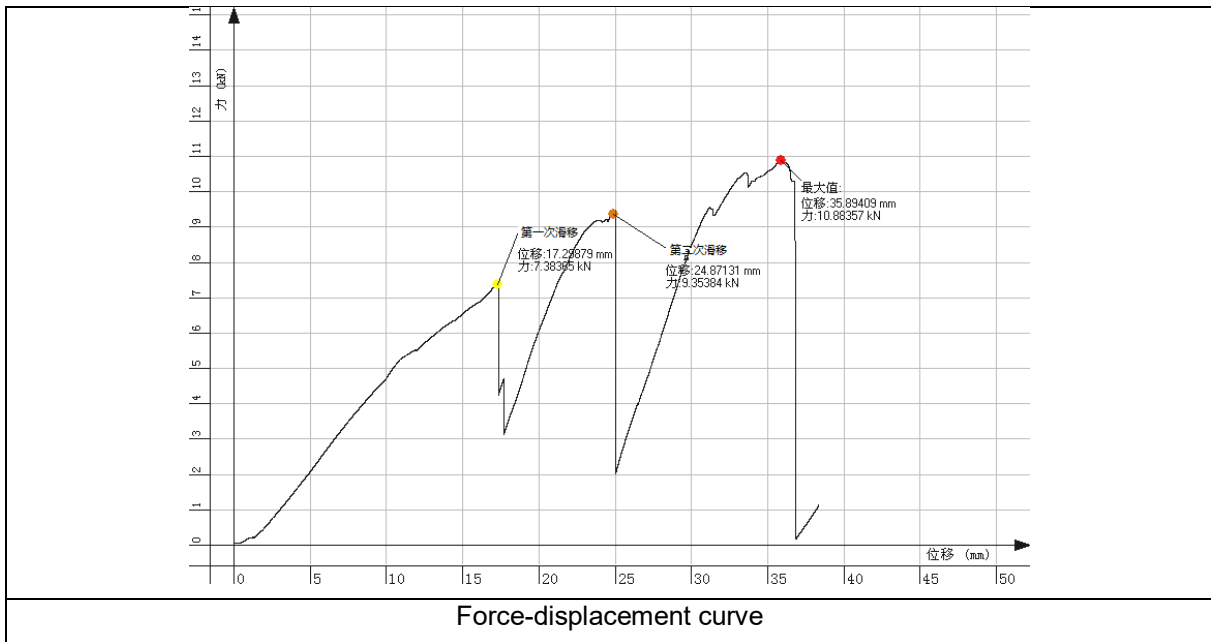
Test curve:

Test item	Maximum force (kN)
Result	10.88

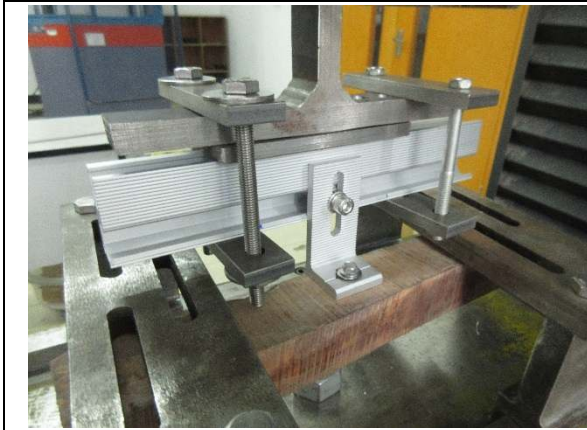
Photo 1: the samples before test

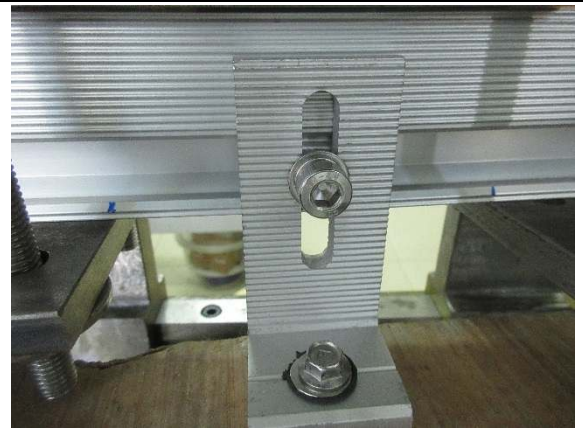
Photo 2: before loading

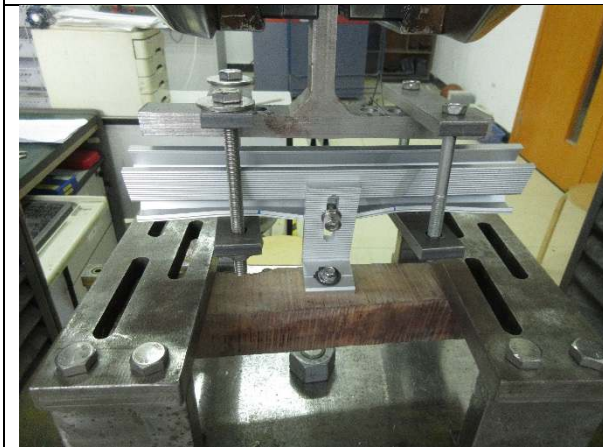
Photo 3: during the test

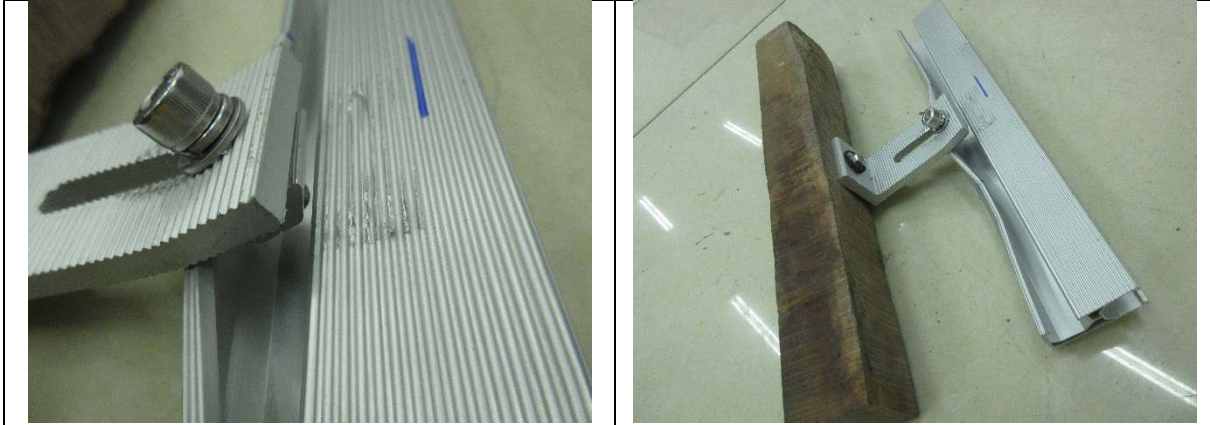
Photo 4: the samples after the test
